APPENDIX A: NORTH 27TH STREET CPTED REVIEW

In July of 2017, a block-by-block CPTED walk, between West State Street and West St. Paul Avenue, was conducted as part of the North 27th Street Corridor Strategy. The following summarizes some initial CPTED observations and recommendations for the North 27th Street commercial corridor.

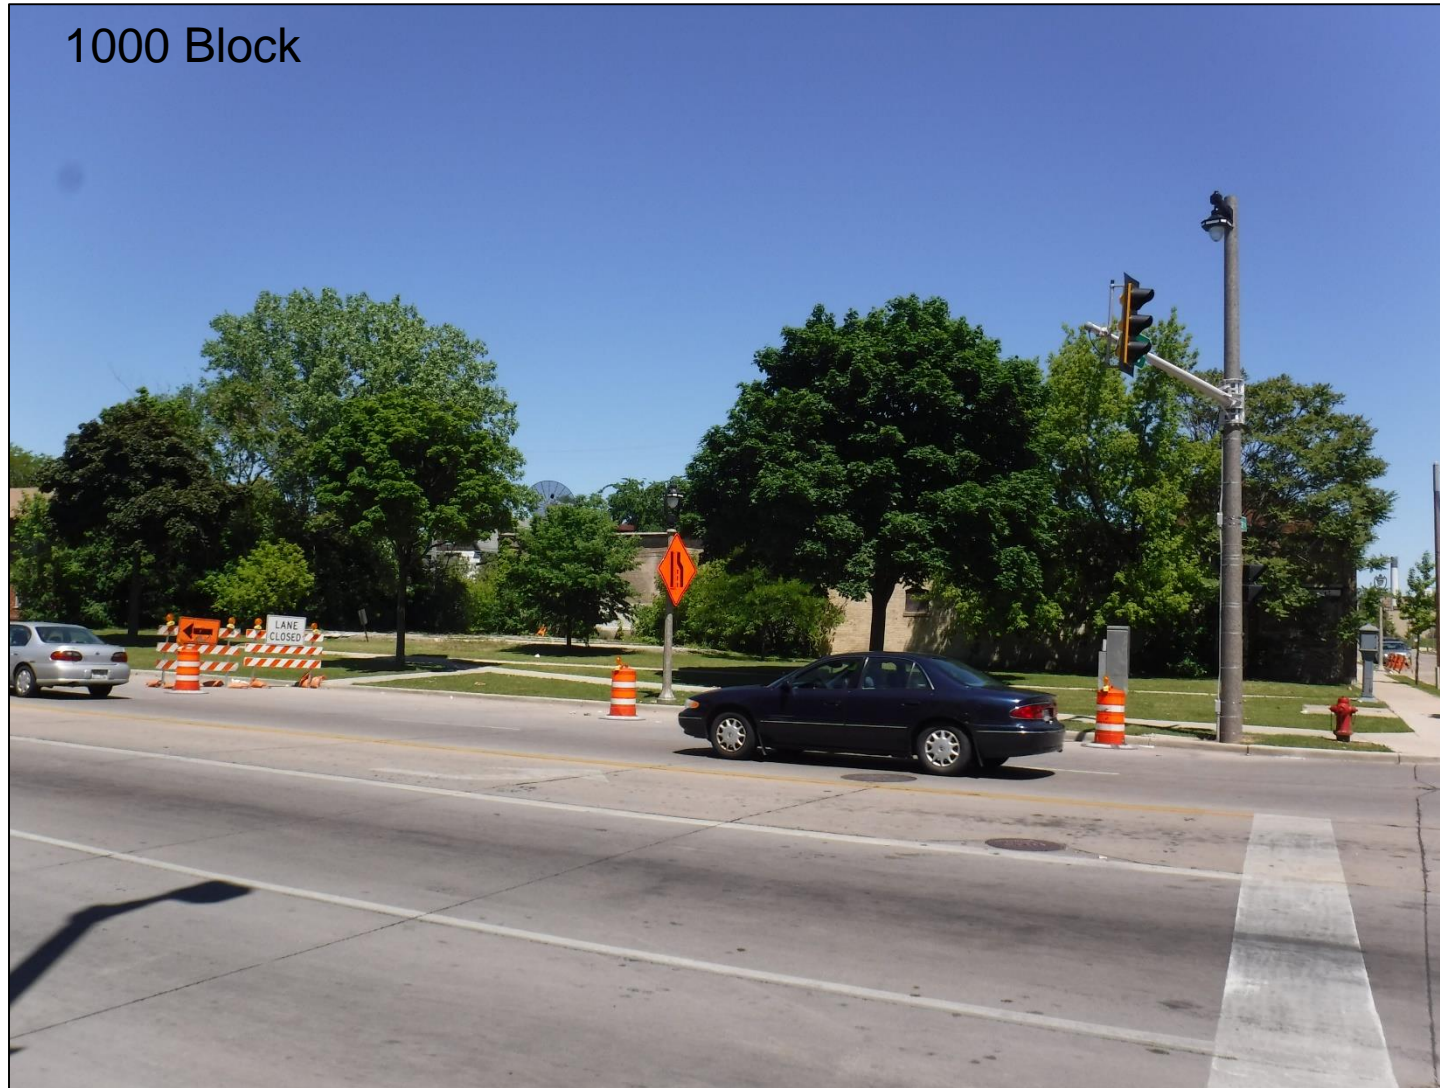
1000 Block

- Tall shrubs and low hanging tree canopies on portions of the property create blind spots.
- Additional lighting should be added to illuminate the corners and dark areas of the lot.

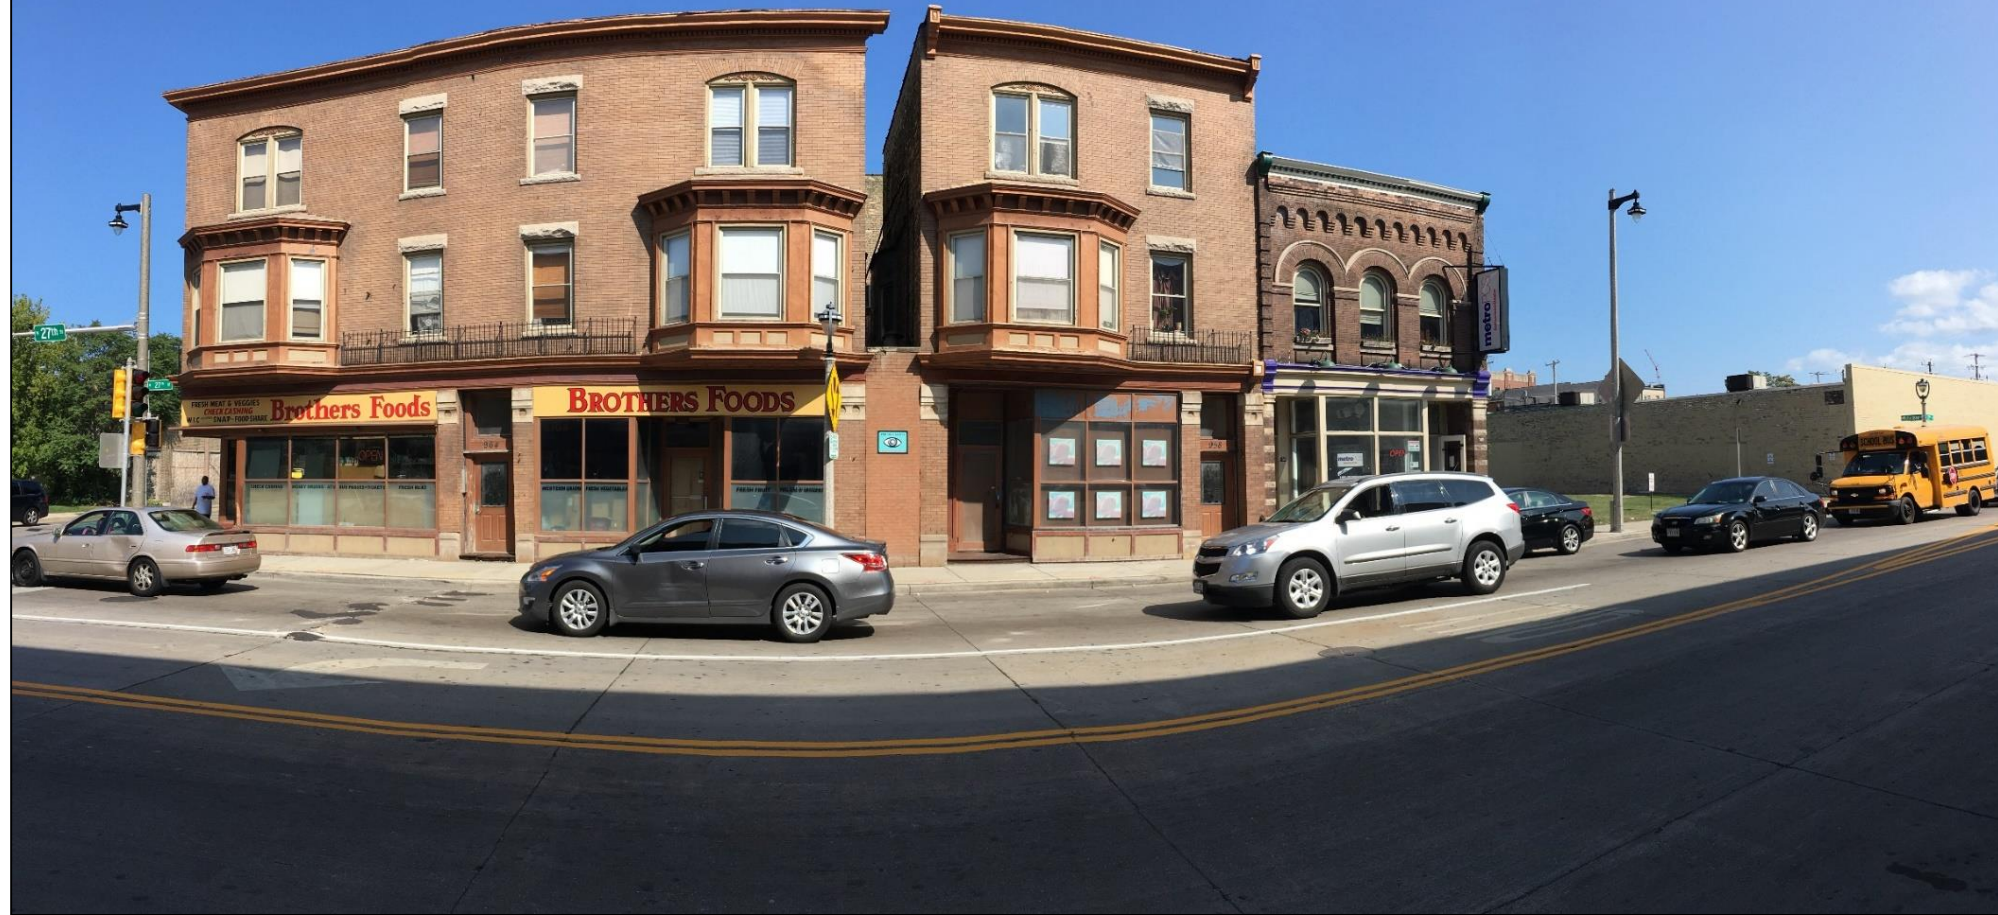
900 Block

- An attractive building at the northern entrance to the commercial corridor.
- Recommended CPTED measures include making the street-fronting windows less obscured by shelving and signage to create a more transparent façade.
- The visibility of the corner front entrance should be improved with lighting and un-obstructed glazing for a more open appearance.

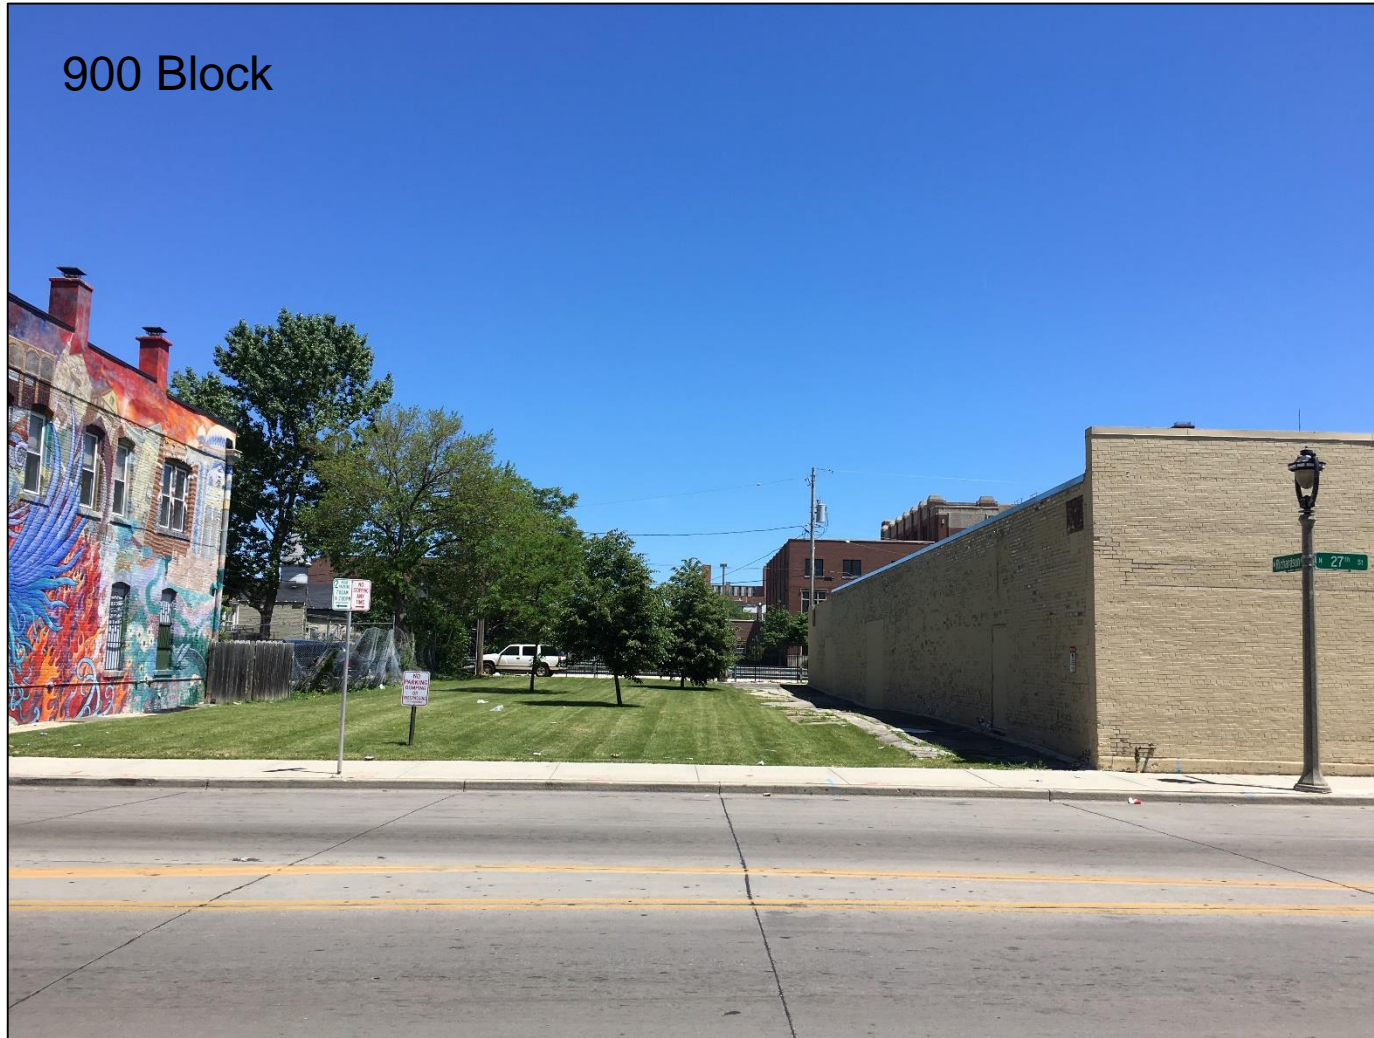
900 Block

- Deteriorated fencing at northern end of the lot invites cut through's and presents an un-kept appearance.
- Landscaping and lack of lighting at rear of lot obscures sightlines.

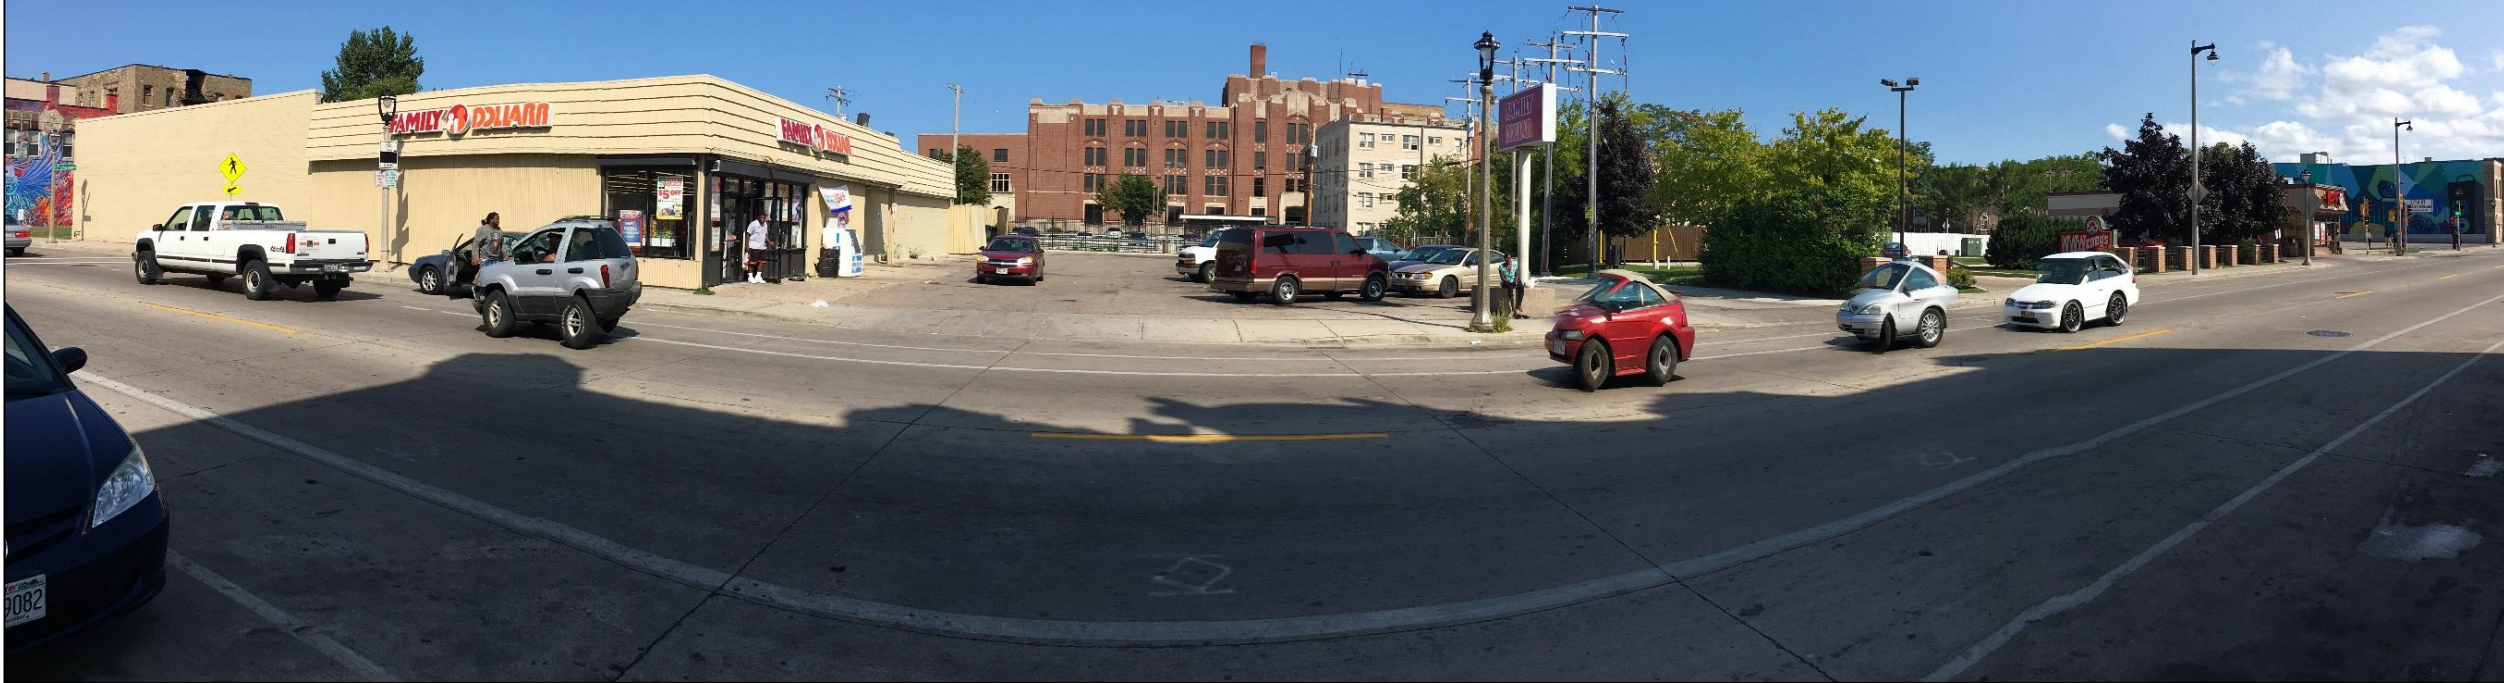
900 Block

- CPTED recommendations include improving the stark and visible blank wall as it detracts from the pedestrian realm and eliminates opportunities for eyes on the street and visibility into the store.
- The surface parking has virtually no landscaping, is untended with debris and the signage pedestal invites loitering and adds to negative perceptions of the corridor and its un-walkability factor.
- Blind spots and nooks on southeast side of building make for potentially unsafe areas.

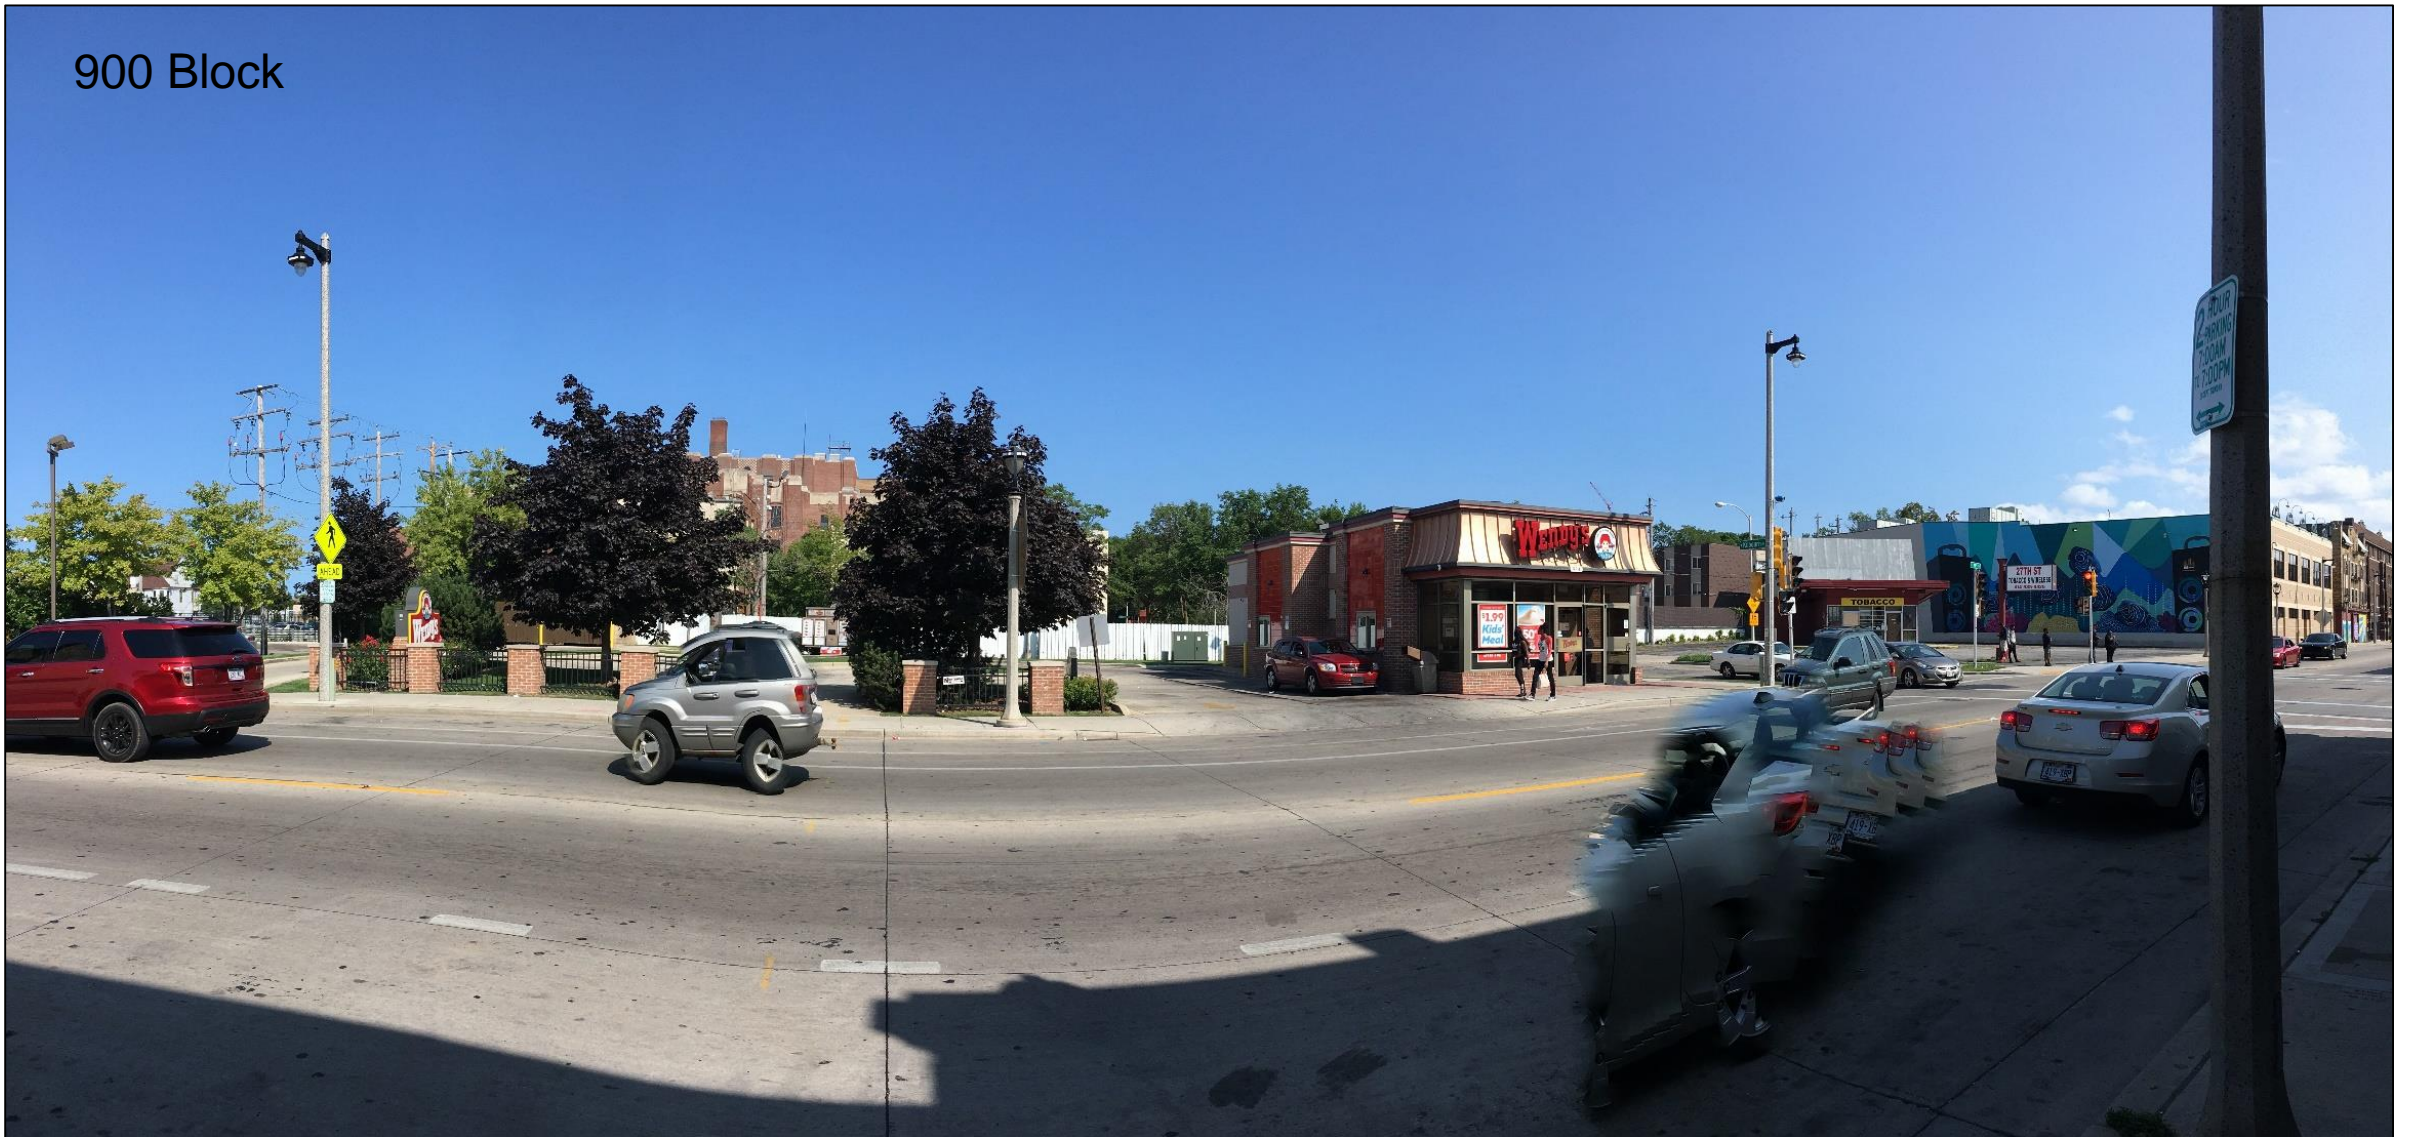
900 Block

- Landscaping and fencing adds to public realm, however some trees and large shrubs obscure sight lines into and out of the parking lot.
- Majority of glazing unobscured by signage but tinted windows reduce visibility into the building.

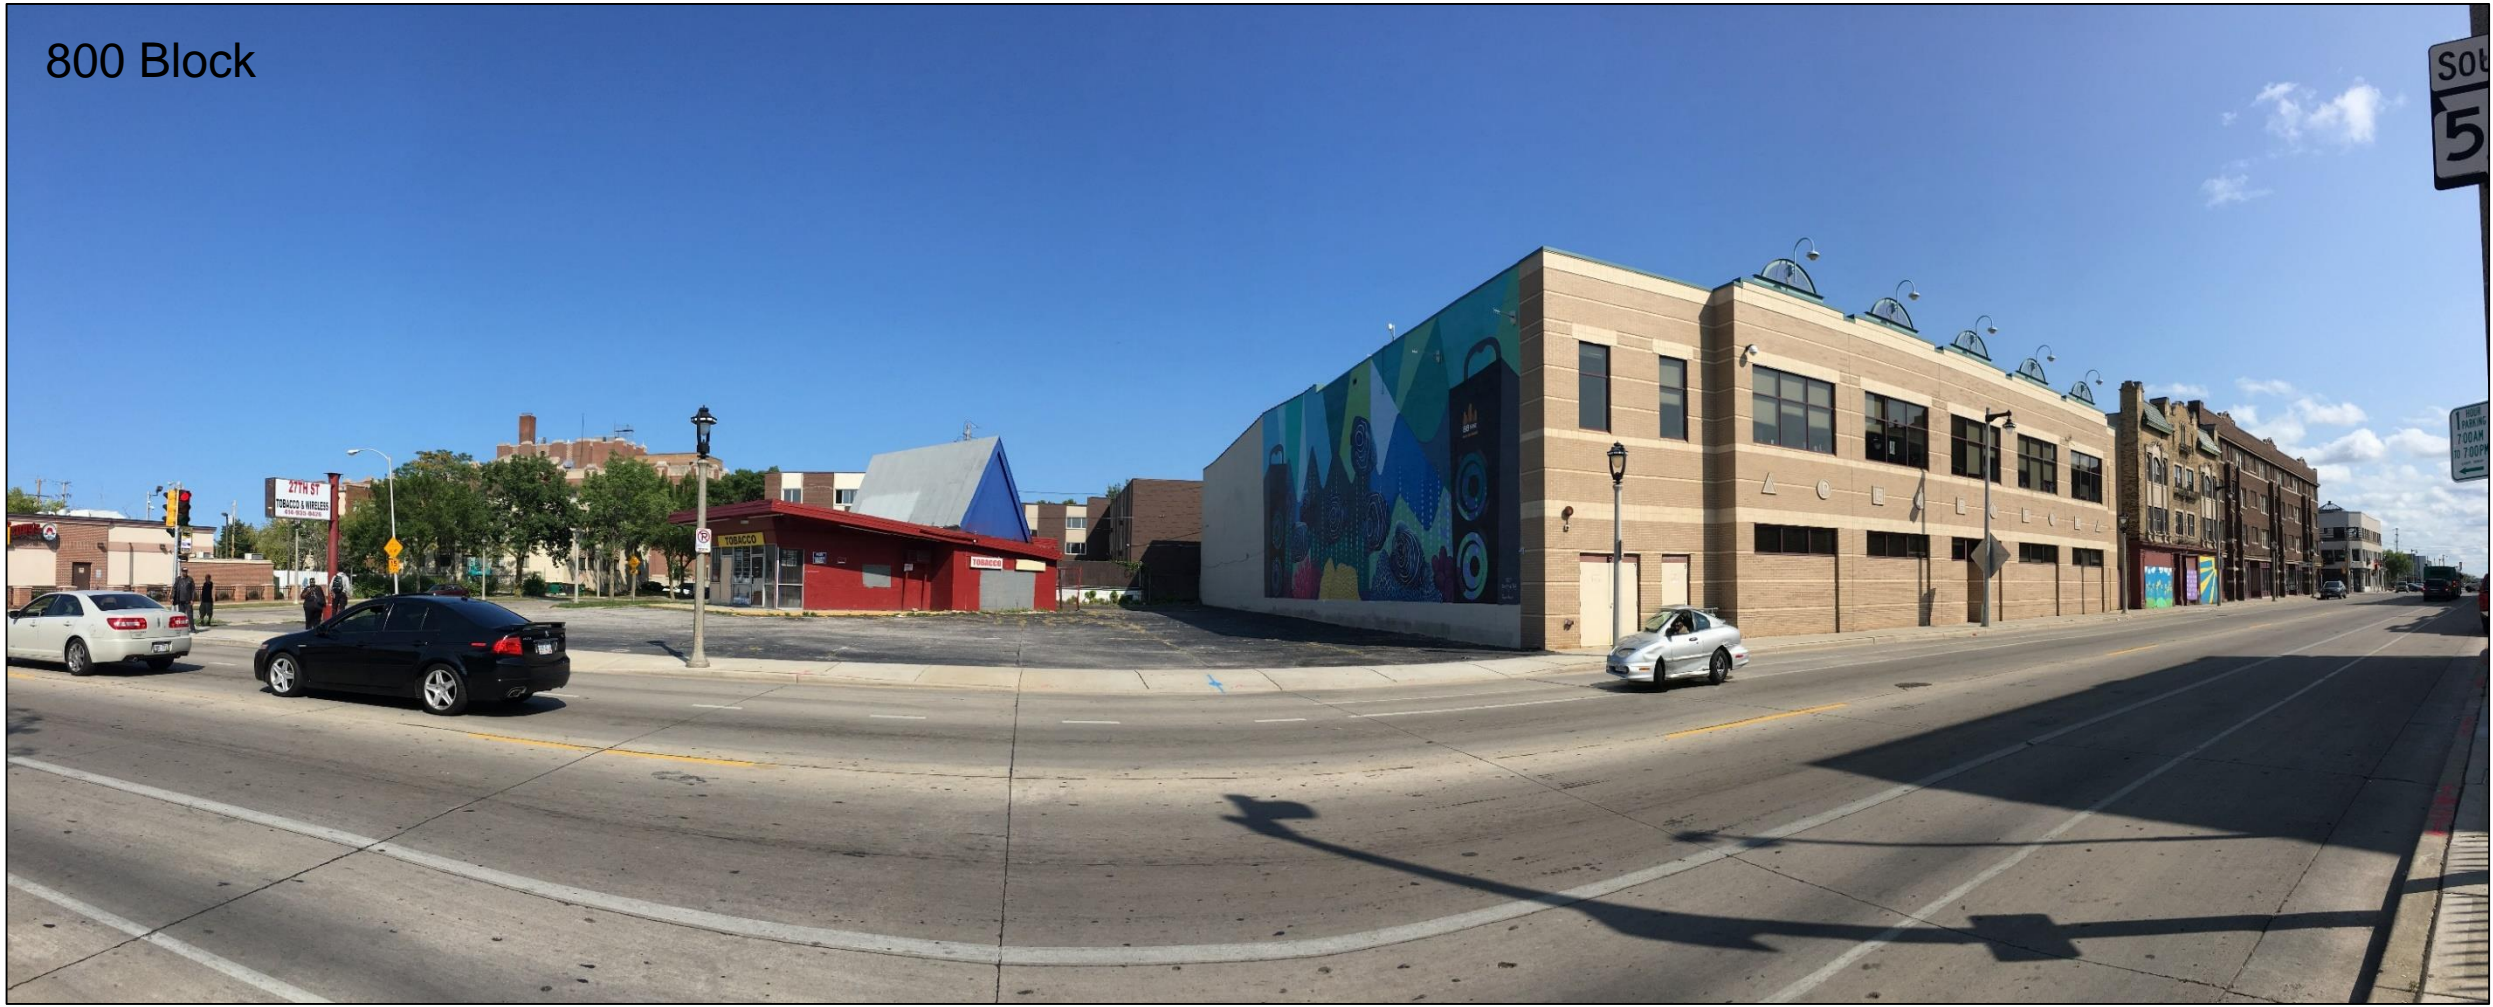
800 Block

- Large, un-landscaped parking lot invites loitering and cut through's by way of corner curb cuts.
- Recommendation to install lighting to southeast corner of property to illuminate area between the three adjacent buildings.
- Blank walls at clinic pedestrian level can be improved with LED lighting or other decorative elements.
- New mural on clinic enlivens and improves the north side of the property.

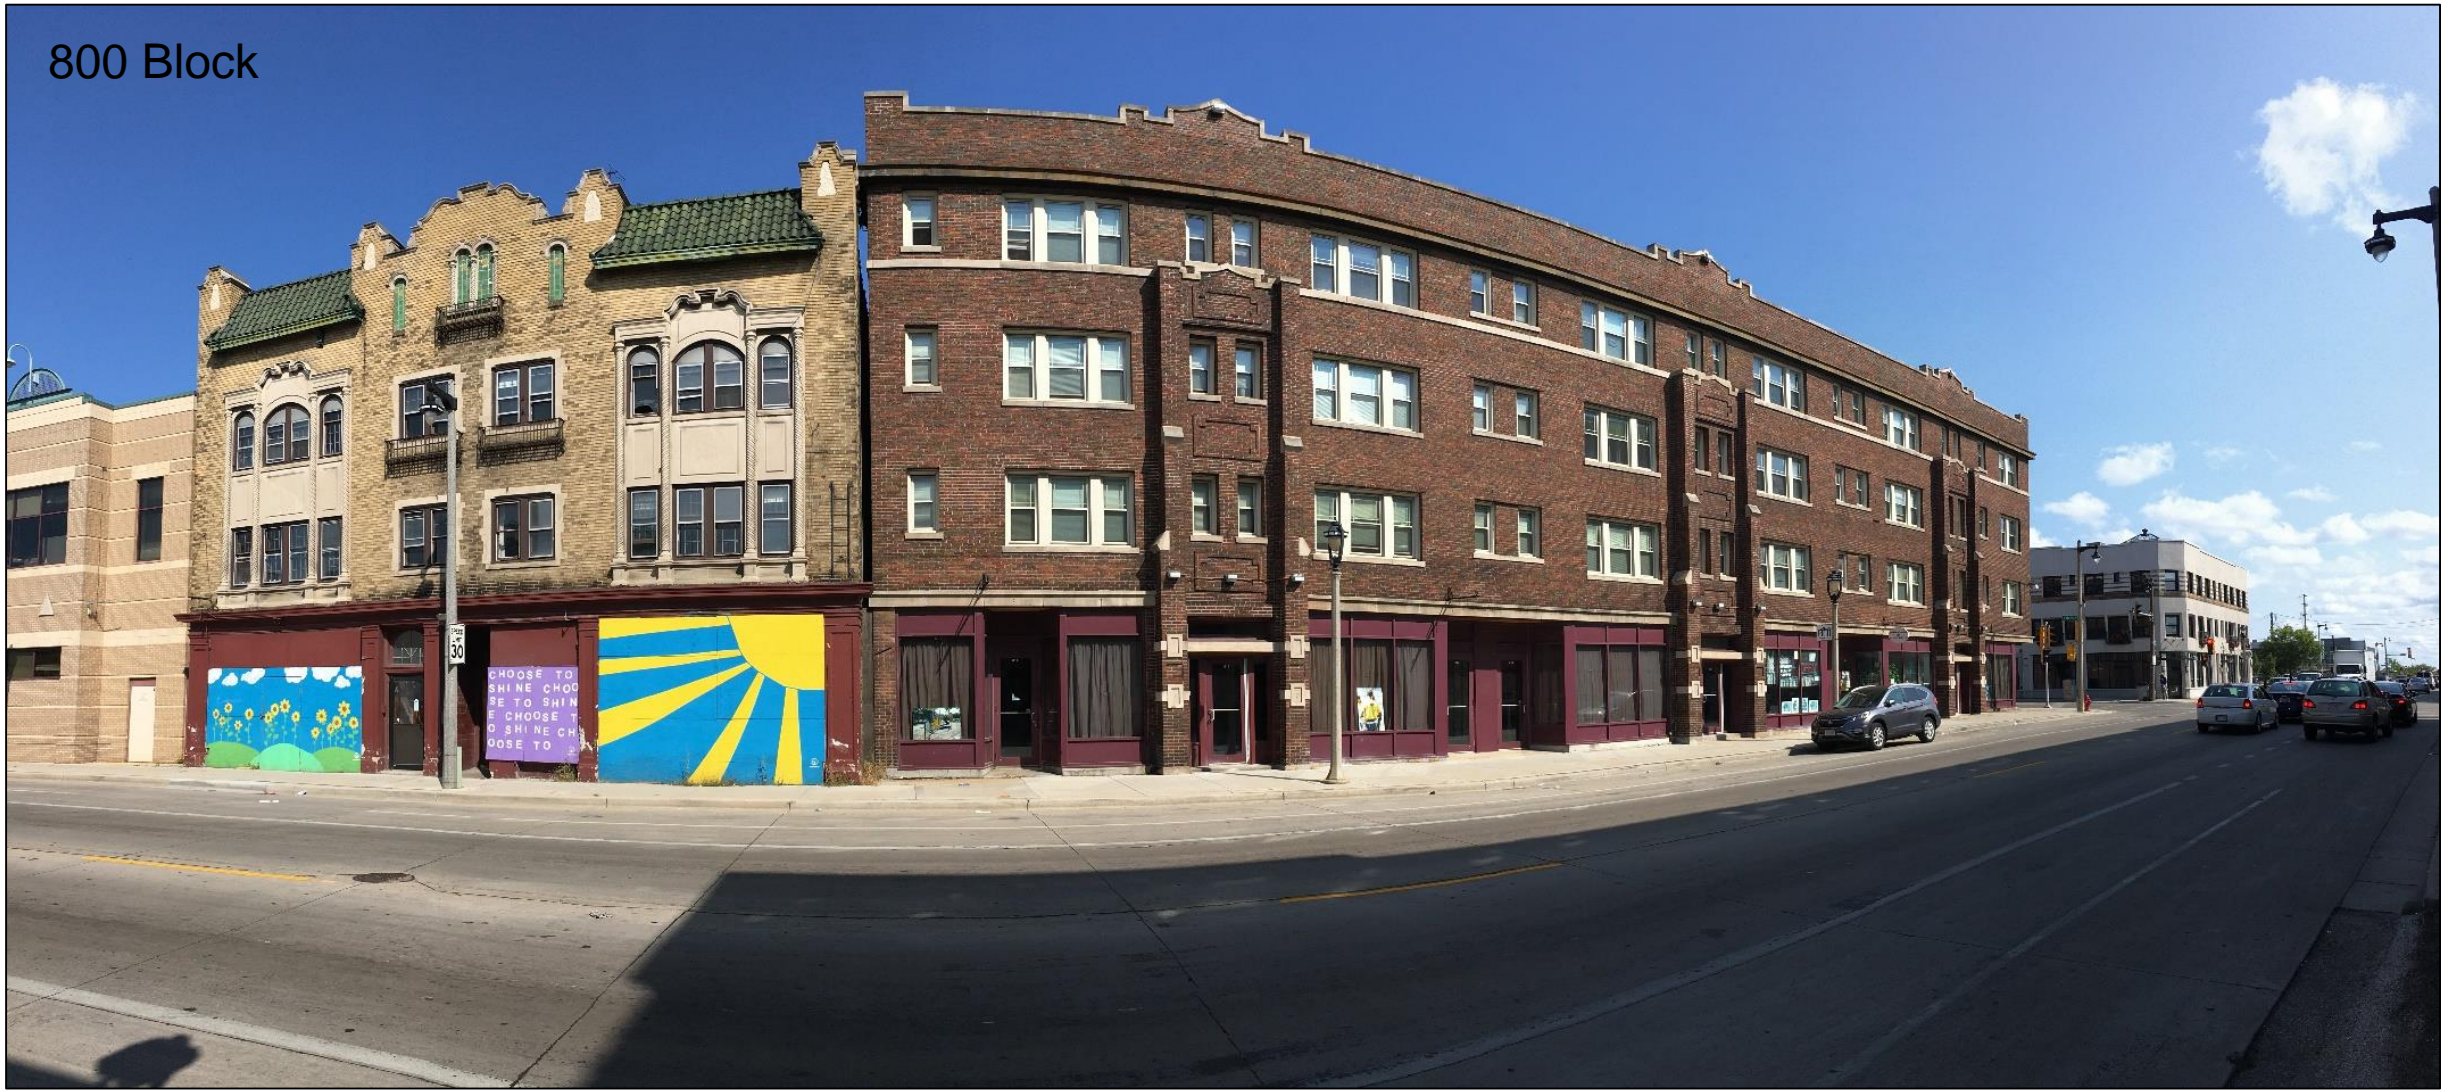
800 Block

- Lighting above doorways aim in all directions limiting effectiveness of properly lighting recessed entry ways.
- Some entry ways are un-kept with litter/debris and detracts from pedestrian realm
- Active commercial storefront near NE corner of N 27th and Wells but windows and front door are obstructed with signage reducing transparency and eyes on the street.

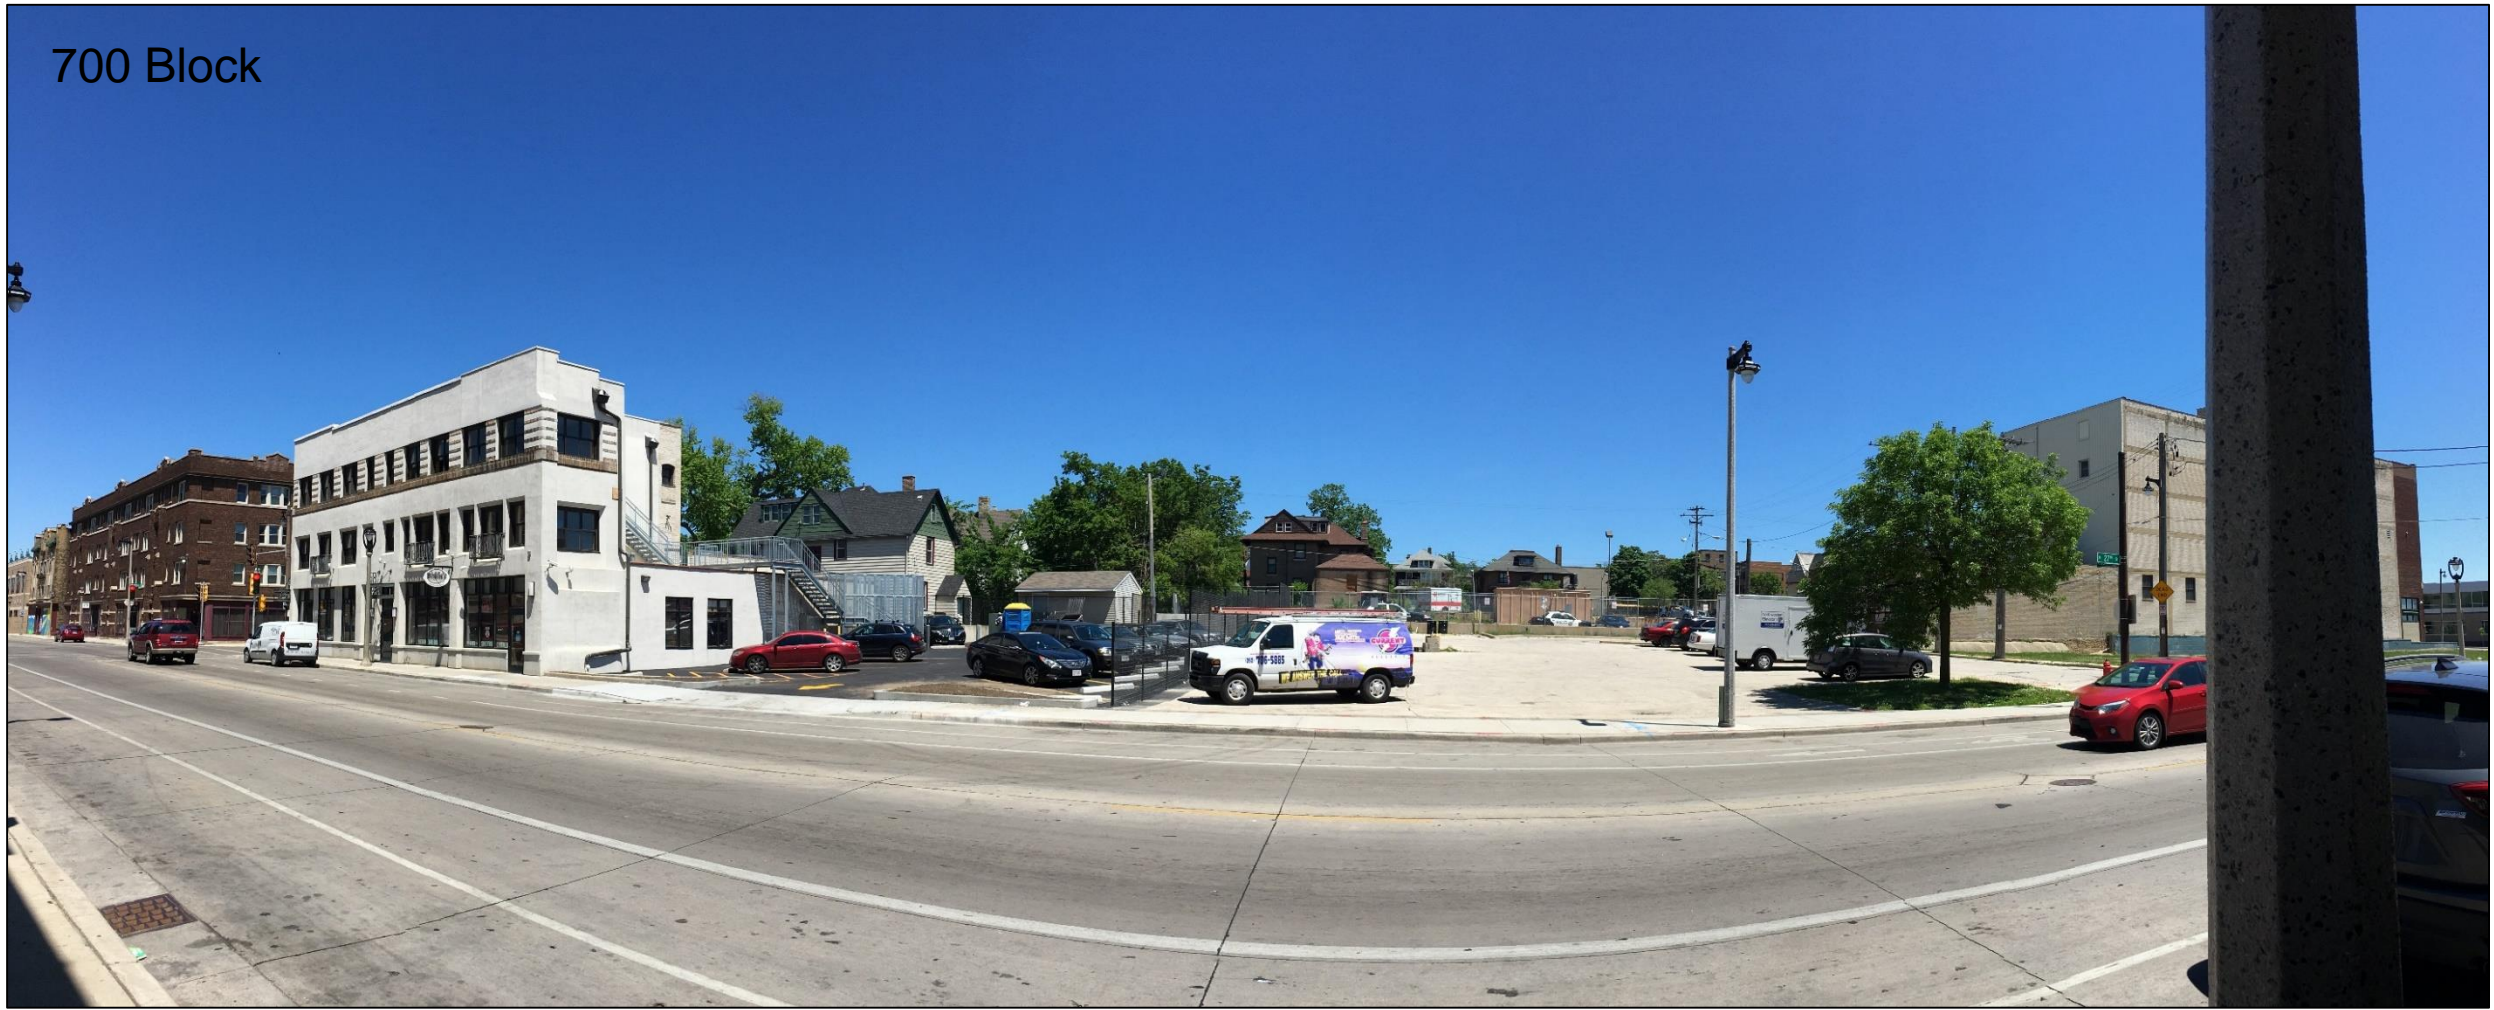
700 Block

- Recently renovated building with retained building features that add value to the public realm
- Restaurant space with well placed window signage and unobscured views creates inviting entrance.
- Southern parking lot is unpaved and lacks landscaping adding to unimproved expanse along the block.

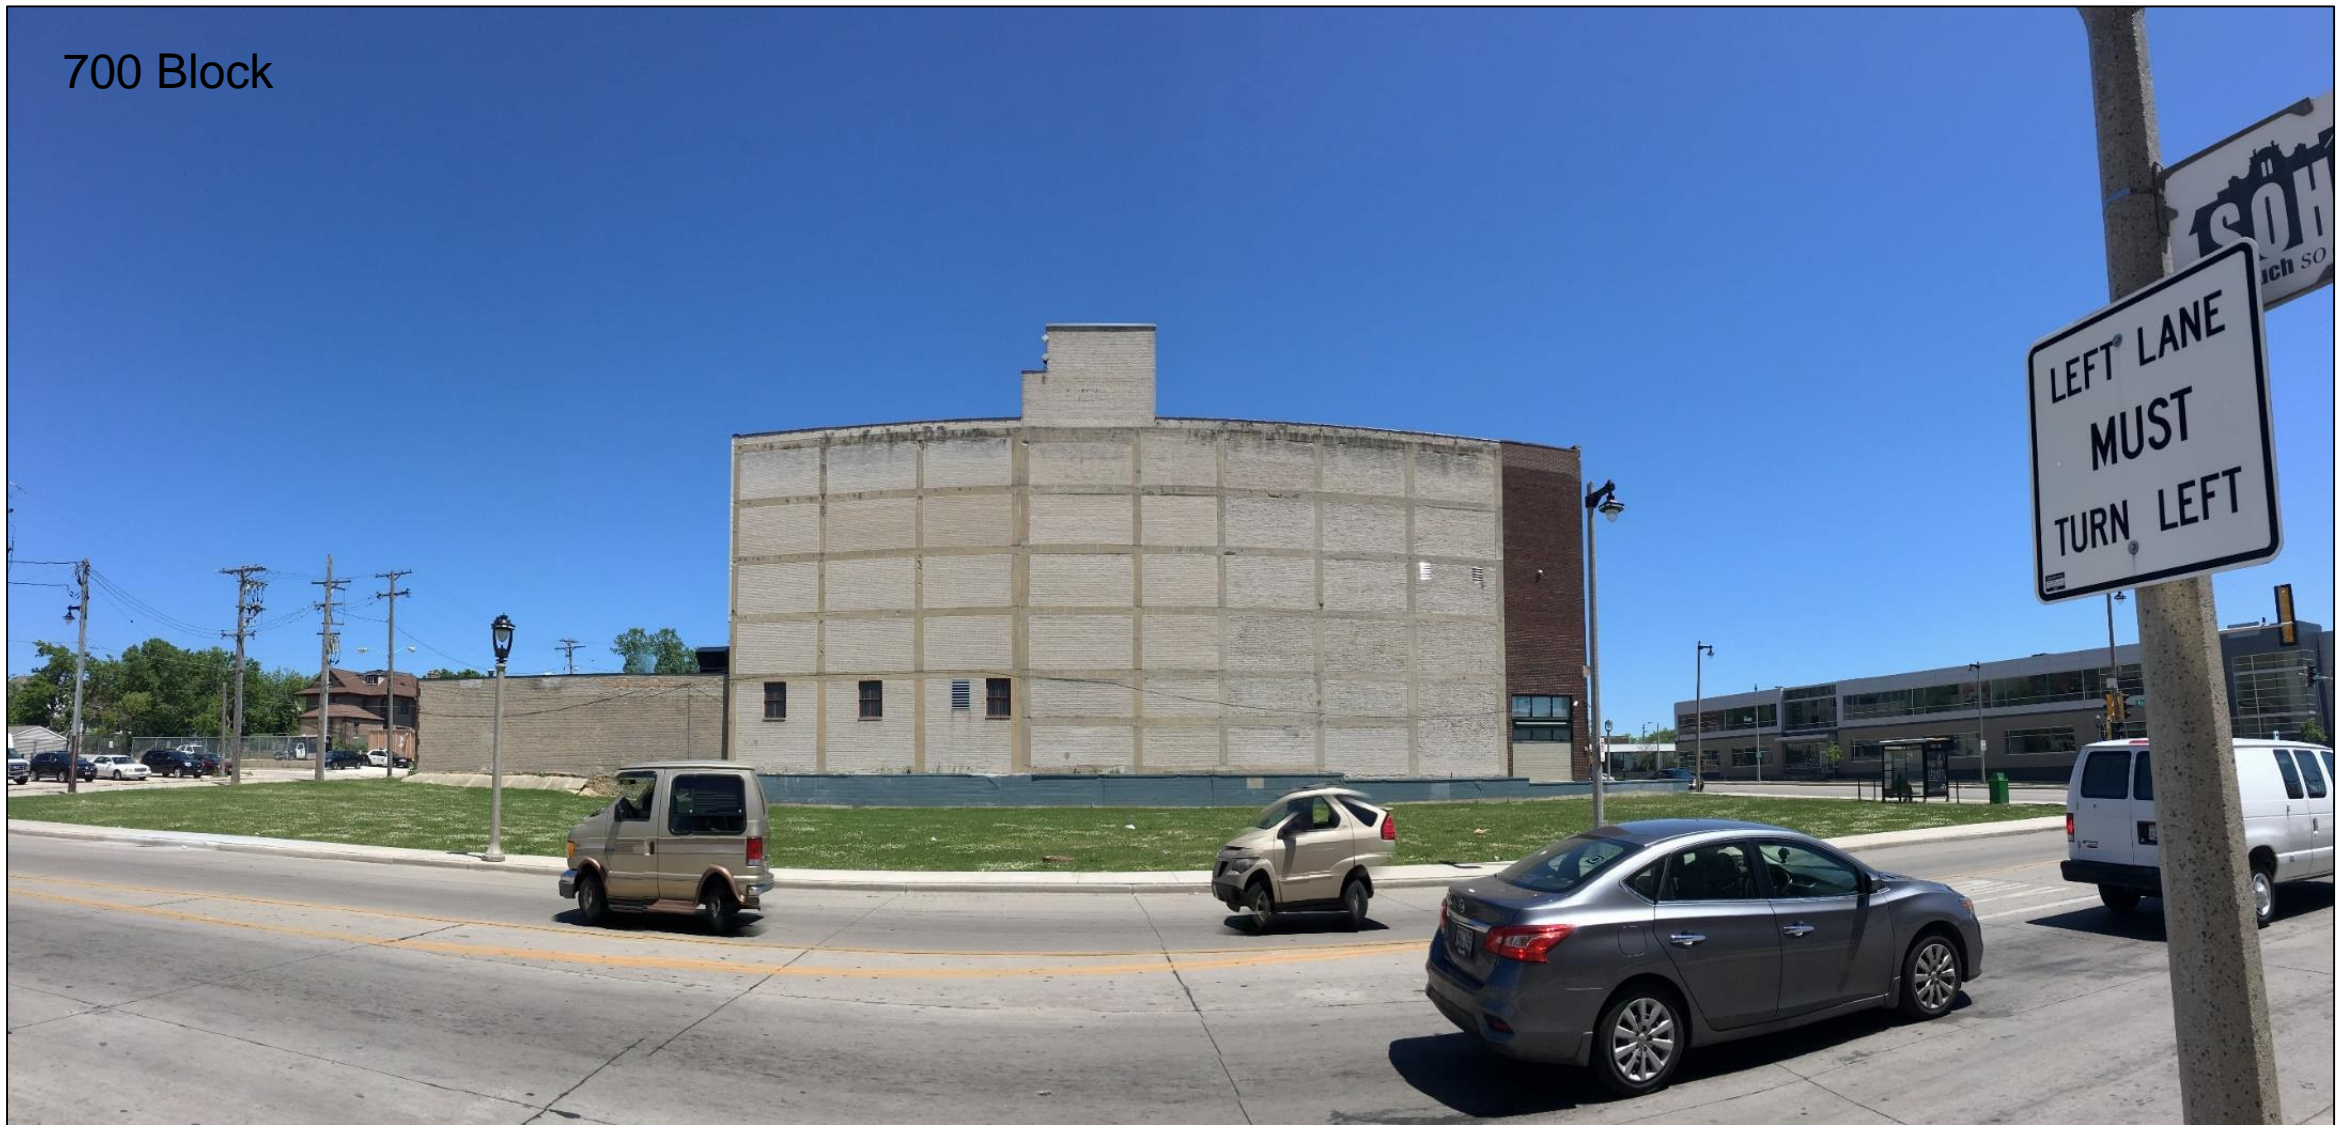
700 Block

- Large vacant lot at key intersection could improve pedestrian realm with tree plantings along perimeter to improve corner and break up expansive blank wall to the east.
- Optimal site for possible Home Grown vacant lot improvement project.

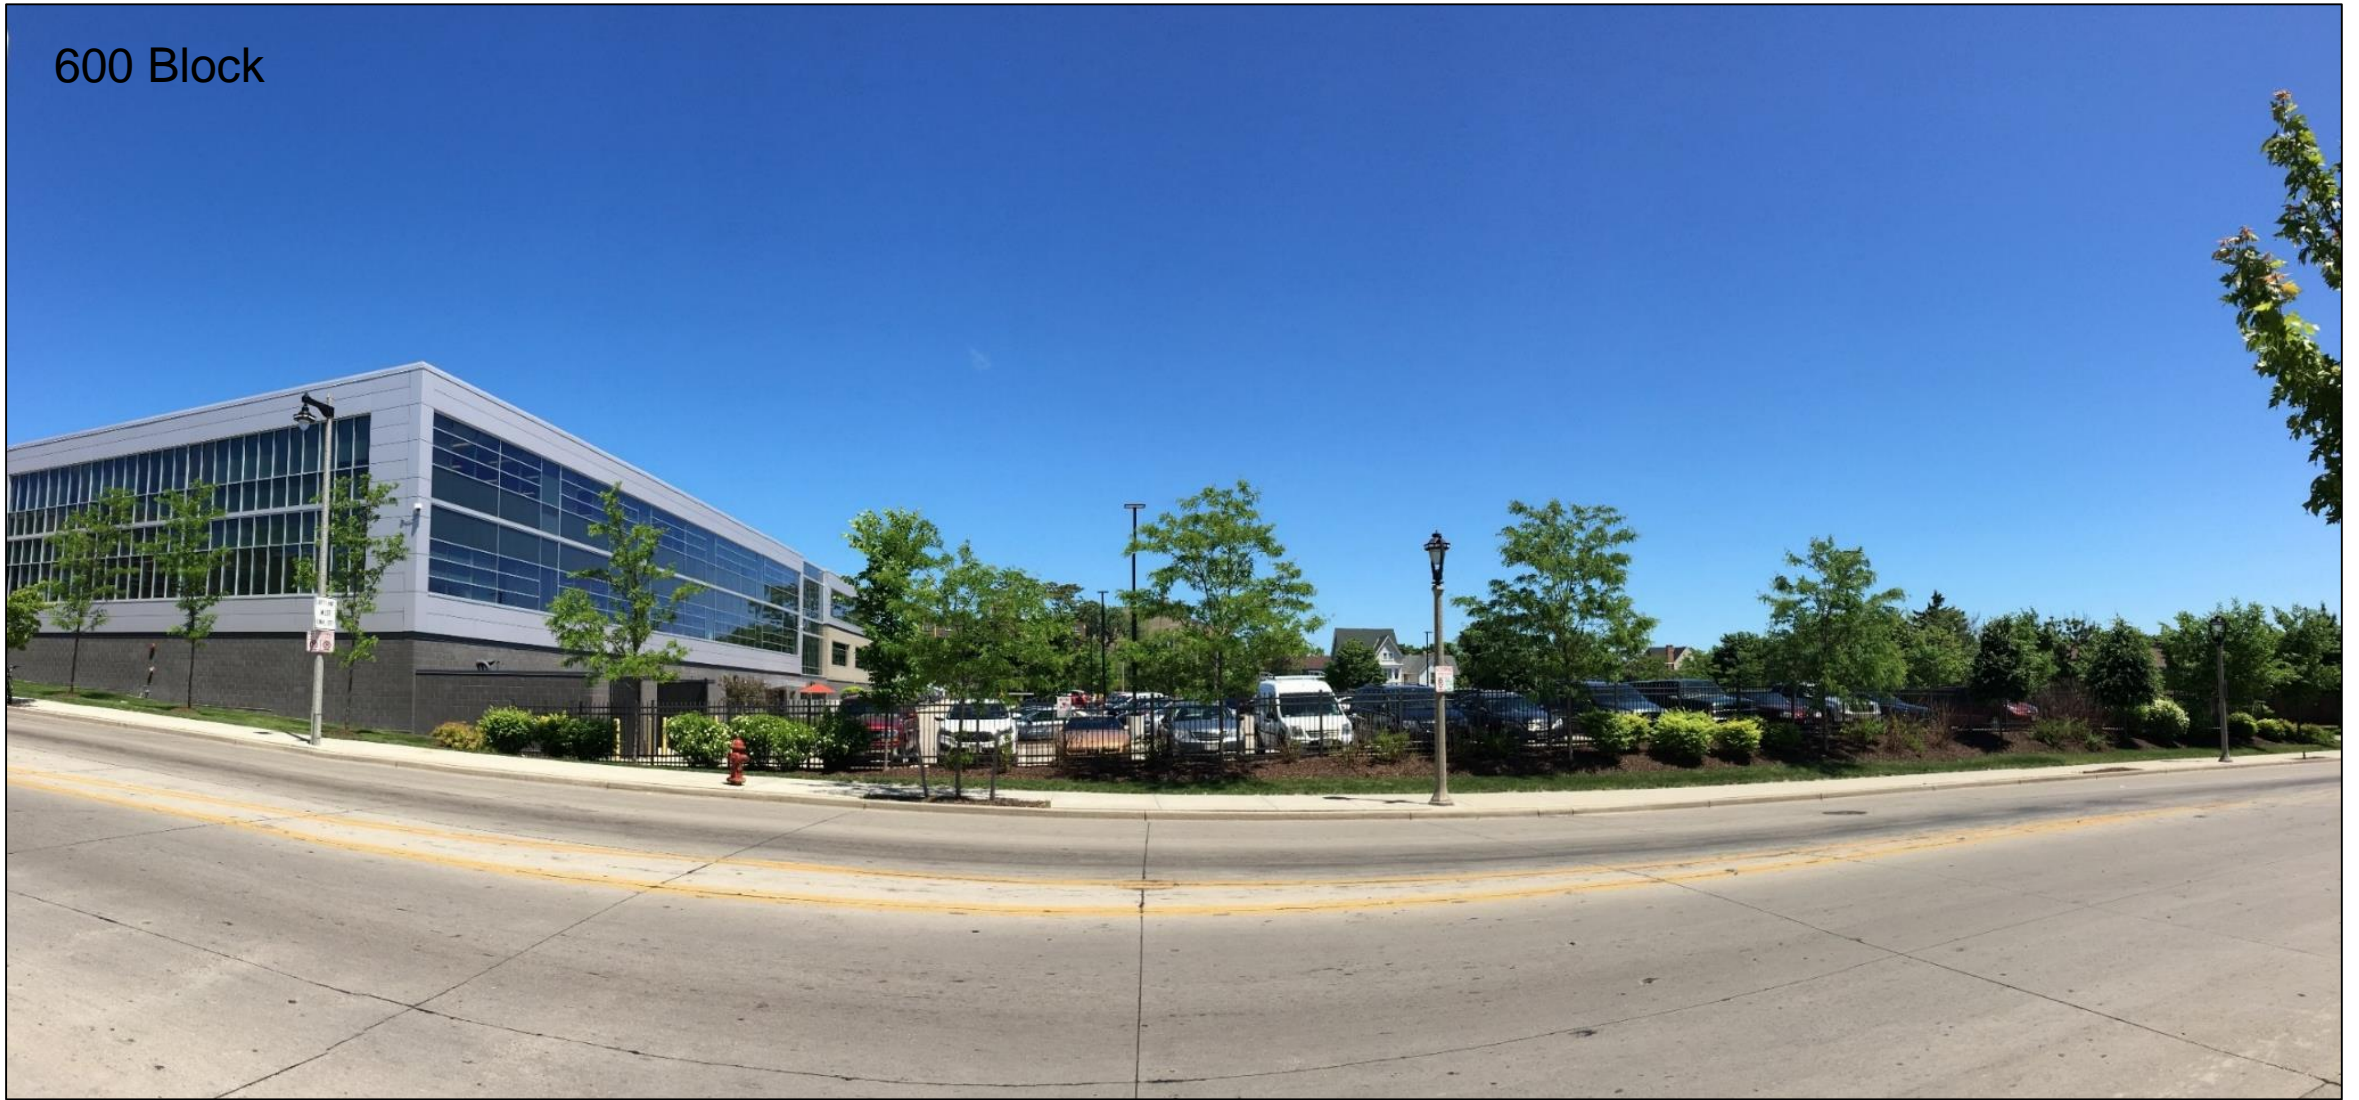
600 Block

- Berm height and larger shrubs obscure sightlines into and out of parking lot.
- Blank wall facing visible North 27th and Wisconsin Avenue intersection can be improved with up-lighting, landscaping or other decorative elements.
